#### 2010 INTERNATIONAL WORKSHOP ON ENVIRONMENT AND ENERGY

# **Environmental Projects for Aerospace Applications**

# Chemical Depainting for Missile and Aviation Systems

# Tagnite Non-Destructive Inspection (NDI) Testing of Magnesium Transmission Housings

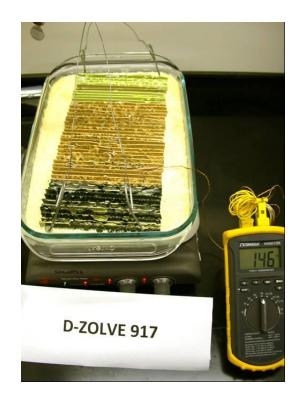
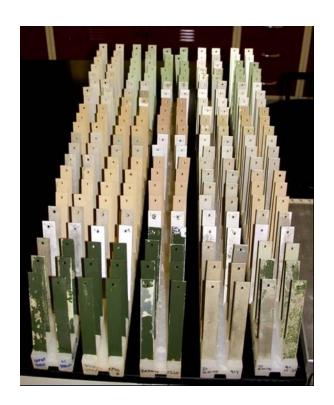
#### **Stripping Efficiency Testing**

- Determination of stripping efficiency
  - 1" x 8" 2024-T3 alodine treated panels with various primers and topcoats
  - For immersion applications, panels were immersed for one hour.
  - For manual applications, panels were racked at a 60° angle and brushed with paint stripper along the top edge. Panels were exposed for 3 and 6 hours.
  - All panels were scraped, rinsed, evaluated, and the % primer and the % substrate revealed were determined.

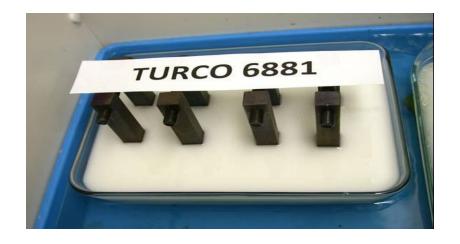
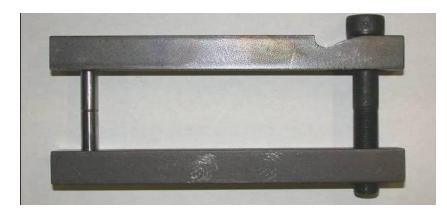
# Chemical Depainting for Missile and Aviation Systems Screening/Hydrogen Embrittlement 1c

- Screening phase originally included hydrogen embrittlement 1c testing. This testing was performed but the specimens were not galvanically isolated from the test fixture. Rather than repeat 1c testing, HE 1d testing was conducted. For this testing, nylon shoulder washers were used for isolation. This caused a short delay in screening results and materials testing.
- Only two immersion and one manual paint stripper passed hydrogen embrittlement 1d testing. The remaining set of panels for materials compatibility testing will be used if needed for retesting.
- Stress corrosion specimens were received flat and must be drawn to shape by an approved procedure prior to sending to CTC.

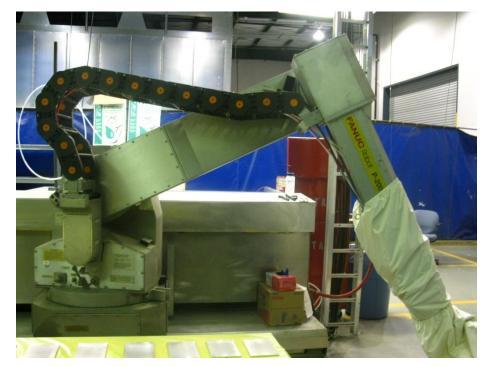
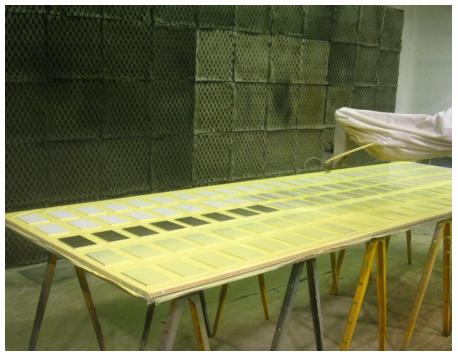
Computerized paint equipment at Concurrent Technologies Corporation applying chromated primer to coupons.

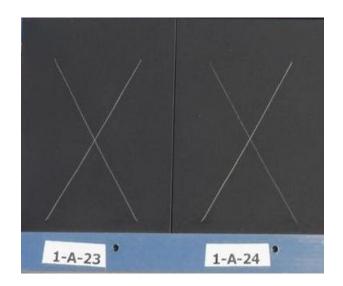
- First mounted on the exposure racks on April 16, 2010 and last evaluated August 17, 2010 at Wittman, AZ.
- The specimens will be assessed per ASTM D1654.
- All magnesium specimens are generally in good condition as of August 2010.

1A=Dow 7/HT Rockhard/23377C/53039 4 months exposure

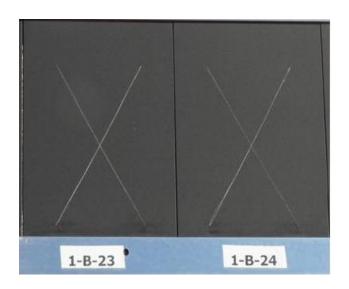
1B=Dow 7/HT Rockhard/23377N/53039 4 months exposure

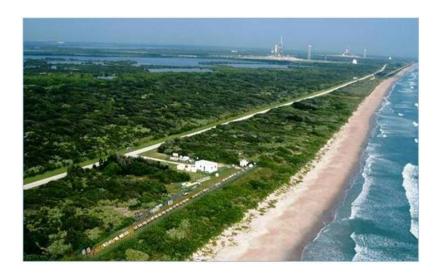
Kennedy Space Center (KSC) Beach Corrosion Site

- Located approximately 1.5 miles south of Launch Complex 39A and situated approximately 150 feet from the mean high tide line.
- First mounted on the exposure racks on May 13<sup>th</sup>, 2010 and evaluated August 13<sup>th</sup>, 2010.
- The specimens will be assessed periodically per ASTM D1654.

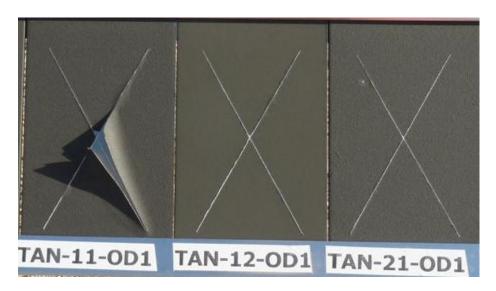
- First mounted on the exposure racks on April 16<sup>th</sup>, 2010 and last evaluated August 17<sup>th</sup>, 2010 in Wittmann, AZ.
- The specimens will be assessed periodically per ASTM D1654.
- Most specimens are generally in good condition as of August 2010.
- One case of coating delamination with the Spectrum EXGWP-508 is noted on the aluminum specimen below. The same coating system has not delaminated during beach exposure to date.

Aluminum panels pretreated with Spectrum EXGWP-508
4 Months Desert Exposure

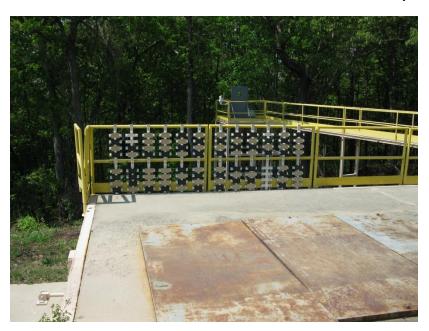
#### **RSA TA5 Outdoor Testing**

- Exposure at Redstone Arsenal, AL; Static Test Area 5, Stand E.
- Three month evaluations were completed the first week of August 2010.
- Aluminum and steel specimens are generally in good condition as of August 2010 with no major differences.
- The specimens will be photographed approximately every 3 month and fully assessed per ASTM D1654 at the end of the 12 month exposure period.
